# Quantitative Percussion Diagnostics (QPD) in a 90-Year- Old Patient with Severe Wear

Real-time data confirms implant health and reassures the patient at two-year follow-up.

## Identifying Tooth Instability in a Geriatric Wear Case Before Symptoms Appear

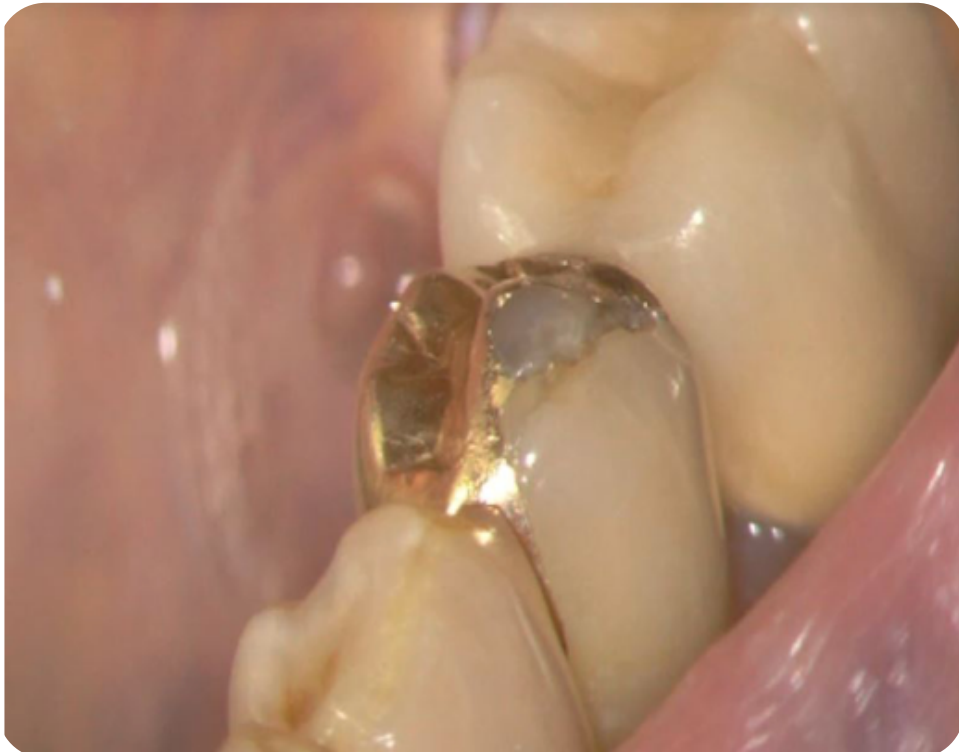
Tooth 29 had a repaired gold only which appeared to be leaking.

From a clinical standpoint, significant wear suggested the likelihood of multiple cracks. Tooth #1 had a severe lingual cusp fracture, and Tooth #29 had an old, inadequately repaired gold onlay that appeared to be leaking.

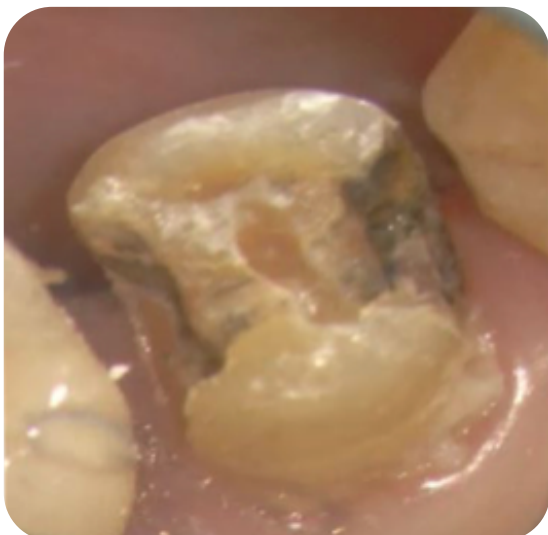
Upon removing the old gold onlay on Tooth 29, significant microleakage was observed on both the mesial and distal box form.

Upon removing the old gold onlay on Tooth 29, significant microleakage was observed on both the mesial and distal box form. Two horizontal cracks were also visible on the buccal cusp.

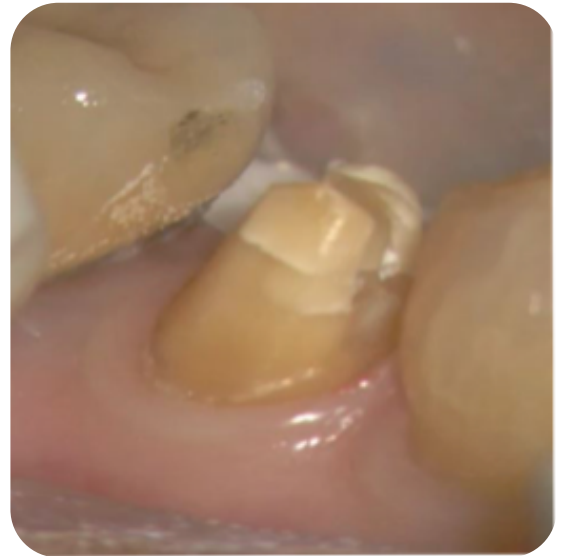
Tooth 29 after initial preparation, after initial preparation exposed two horizontal cracks on the buccal cusp. A full-coverage ceramic restoration was placed to protect the tooth from further breakdown.
